# Smoke and Dye Testing Summary

## High Level Sewershed

Test ID	Test Type	Date Inspected	Company / Super.	Blower MH	Ground Condition	Notification Made?	Total Length
S1028-241	Smoke	8/24/2009	ADS/TM	S19QQ_005MH	Dry	Yes	806.74

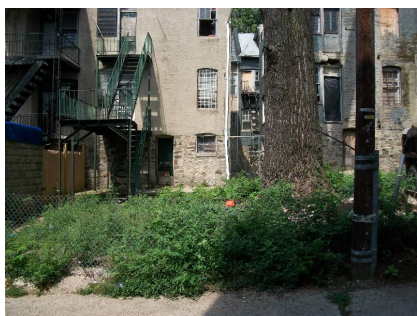
**Picture** \S1028-241-OB01-P01.jpg

**Comments** Smoke from cleanout in back yard. 2205 Liberty Heights Ave.

**Comments** Back of house, 2205 Liberty Heights Ave.

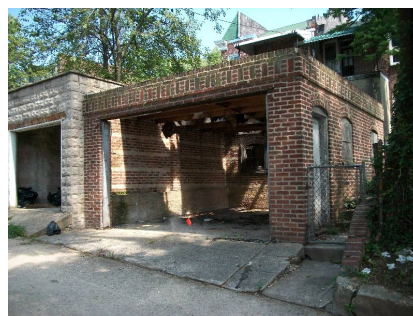
**Picture** \S1028-241-OB02-P01.jpg

**Comments** Smoke from service lateral under paved concrete behind house. 3414 Woodbrook Ave.

**Comments** Back of house, 3414 Woodbrook Ave.

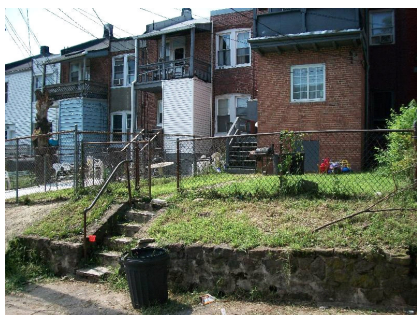
**Picture** \S1028-241-OB03-P01.jpg

**Comments** Smoke from service lateral under paved concrete stairs behind house. 2521 Reisterstown Rd.

**Comments** Back of house, 2521 Reisterstown Rd.

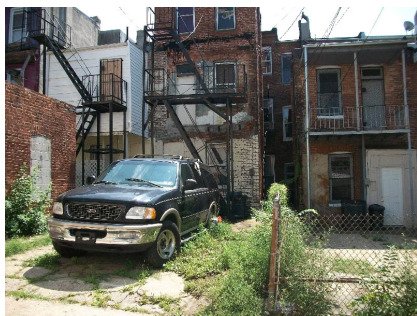
**Picture** \S1028-241-OB05-P01.jpg

**Comments** Smoke from cleanout in back yard. 1706 Gwynns Falls Pkwy.

**Comments** Back of house, 1706 Gwynns Falls Pkwy.

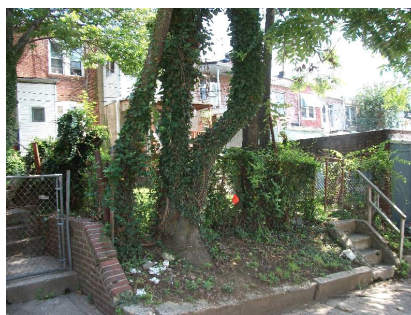
**Picture** \S1028-241-OB04-P01.jpg

**Comments** Smoke from cleanout in back yard. 3412 Woodbrook Ave.

**Comments** Back of house, 3412 Woodbrook Ave.
